## FOTO SURVEY KONDISI JALAN TAHUN 2021

RUAS JALAN : JL. CINGEBUL-KERTAJAYA

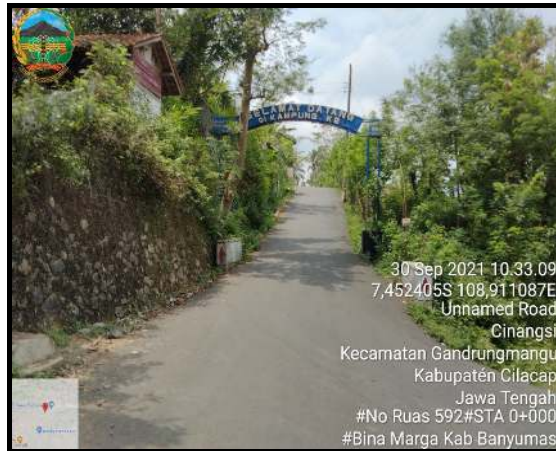
LOKASI :           **STA                   0+000**

KONDISI PERKERASAN :       Baik  
LEBAR PERKERASAN :       4,2           M  
CATATAN :               Hotmix

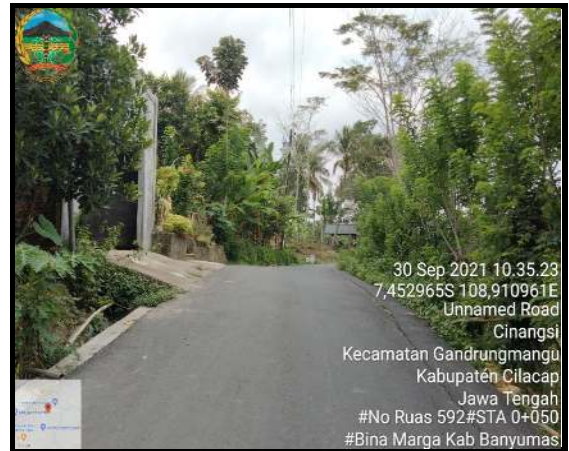
LOKASI :           **STA                   0+050**

KONDISI PERKERASAN :       Sedang  
LEBAR PERKERASAN :       4,2           M  
CATATAN :               Hotmix

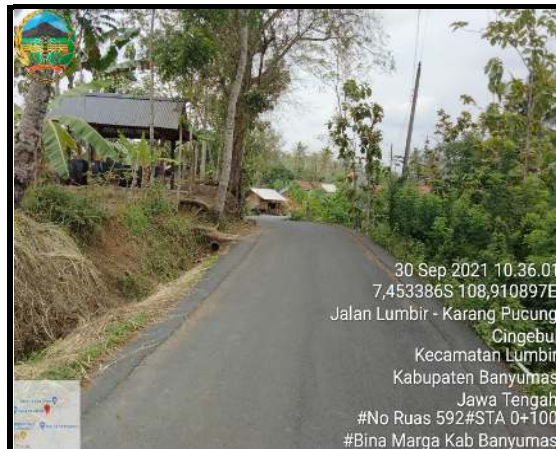
LOKASI :           **STA                   0+100**

KONDISI PERKERASAN :       Sedang  
LEBAR PERKERASAN :       4,2           M  
CATATAN :               Hotmix

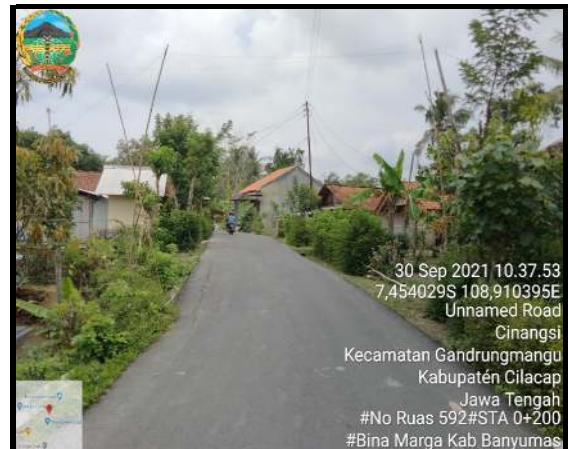
LOKASI :           **STA                   0+200**

KONDISI PERKERASAN :       Sedang  
LEBAR PERKERASAN :       4,2           M  
CATATAN :               Hotmix

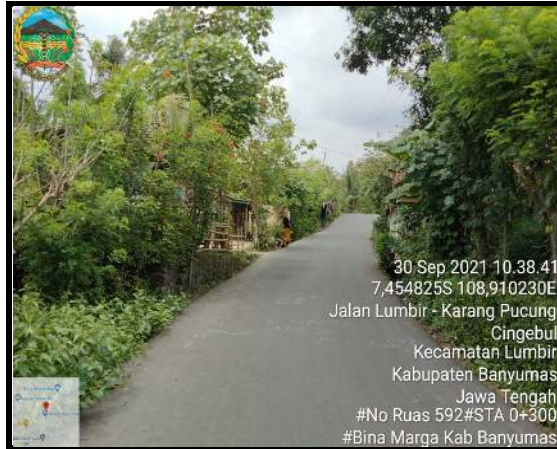
LOKASI : STA 0+300

KONDISI PERKERASAN : Baik  
LEBAR PERKERASAN : 4,2 M  
CATATAN : Hotmix

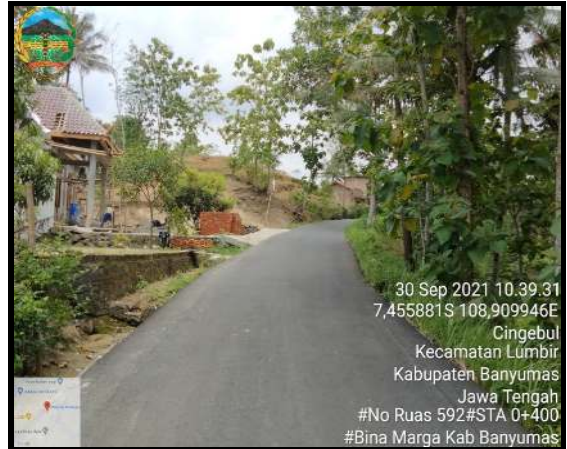
LOKASI : STA 0+400

KONDISI PERKERASAN : Sedang  
LEBAR PERKERASAN : 4,2 M  
CATATAN : Hotmix

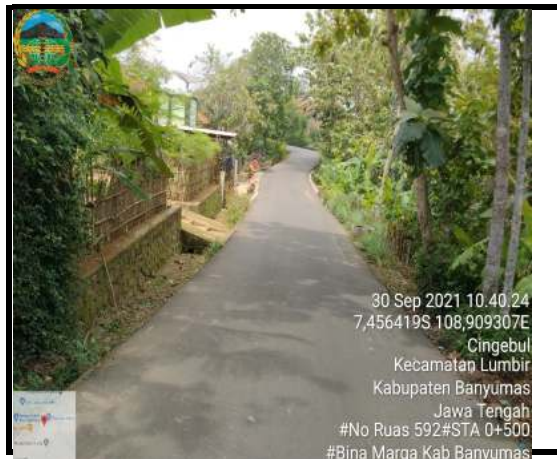
LOKASI : STA 0+500

KONDISI PERKERASAN : Sedang  
LEBAR PERKERASAN : 4,2 M  
CATATAN : Hotmix

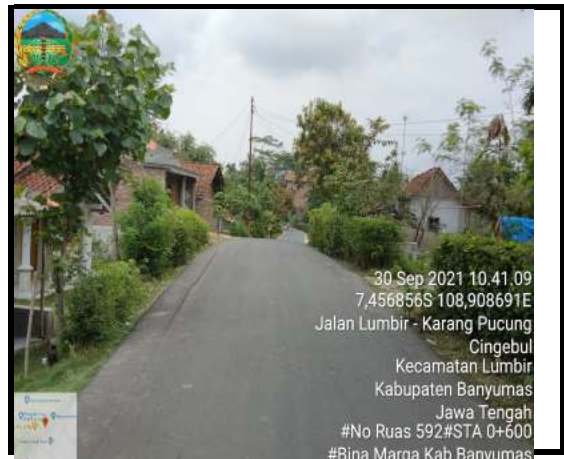
LOKASI : STA 0+600

KONDISI PERKERASAN : Sedang  
LEBAR PERKERASAN : 4,2 M  
CATATAN : Hotmix

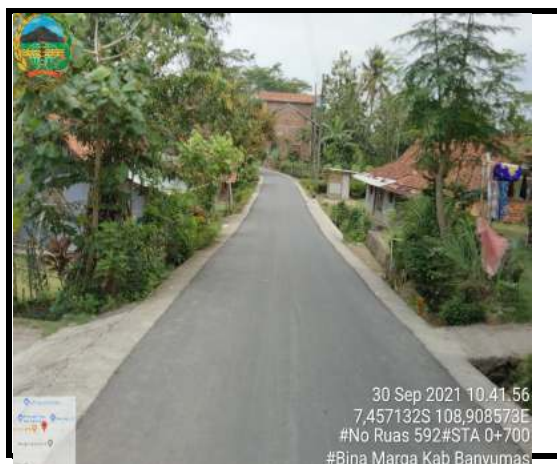
LOKASI :           **STA           0+700**

KONDISI PERKERASAN :       Baik  
LEBAR PERKERASAN :       3,4           M  
CATATAN :               Hotmix

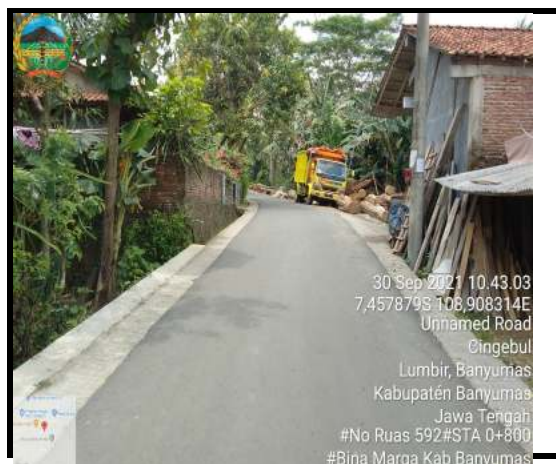
LOKASI :           **STA           0+800**

KONDISI PERKERASAN :       Baik  
LEBAR PERKERASAN :       3,4           M  
CATATAN :               Hotmix

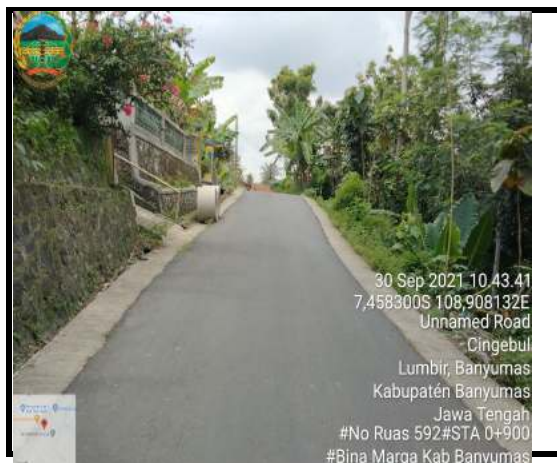
LOKASI :           **STA           0+900**

KONDISI PERKERASAN :       Baik  
LEBAR PERKERASAN :       3,4           M  
CATATAN :               Hotmix

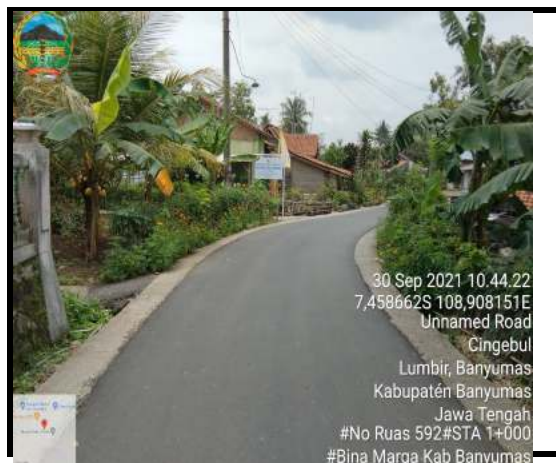
LOKASI :           **STA           1+000**

KONDISI PERKERASAN :       Baik  
LEBAR PERKERASAN :       3,4           M  
CATATAN :               Hotmix

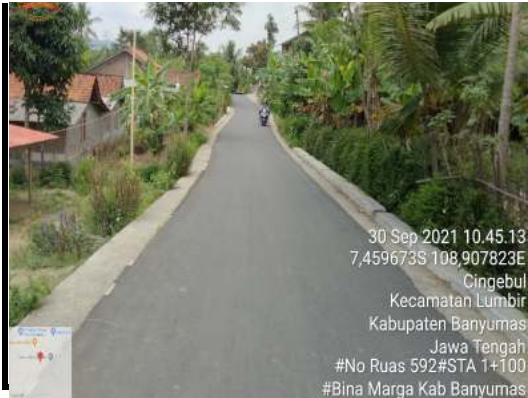
LOKASI :           **STA**                   **1+100**

KONDISI PERKERASAN           :   Baik

LEBAR PERKERASAN            :   3,4            M

CATATAN                         :   Hotmix

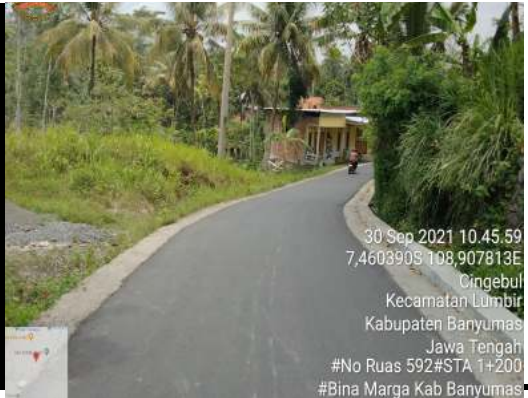
LOKASI :           **STA**                   **1+200**

KONDISI PERKERASAN           :   Baik

LEBAR PERKERASAN            :   3,4            M

CATATAN                         :   Hotmix

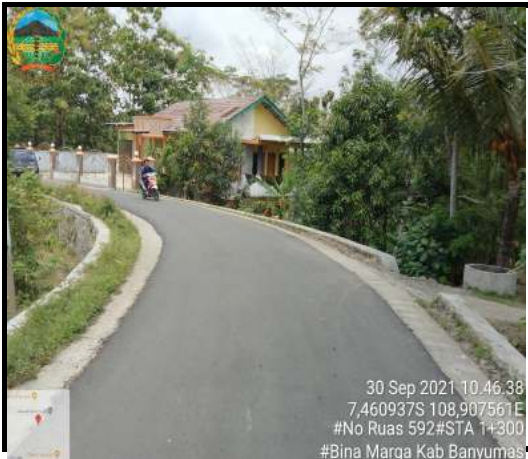
LOKASI :           **STA**                   **1+300**

KONDISI PERKERASAN           :   Baik

LEBAR PERKERASAN            :   3,4            M

CATATAN                         :   Hotmix

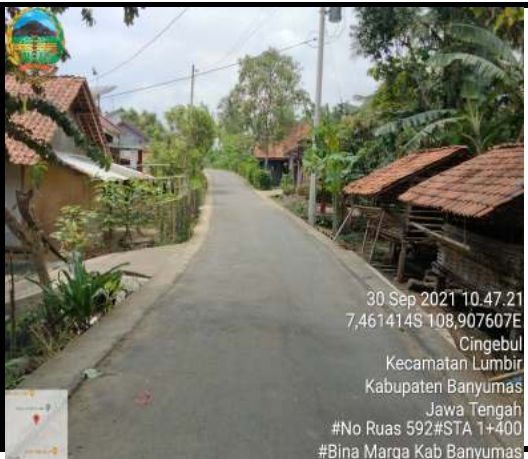
LOKASI :           **STA**                   **1+400**

KONDISI PERKERASAN           :   Baik

LEBAR PERKERASAN            :   3,4            M

CATATAN                         :   Hotmix

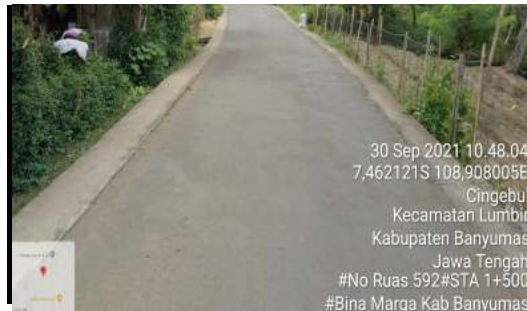
LOKASI : STA 1+500

KONDISI PERKERASAN : Baik  
LEBAR PERKERASAN : 3,4 M  
CATATAN : Hotmix

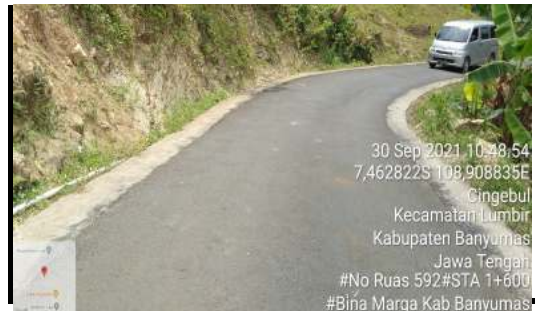
LOKASI : STA 1+600

KONDISI PERKERASAN : Baik  
LEBAR PERKERASAN : 3,4 M  
CATATAN : Hotmix

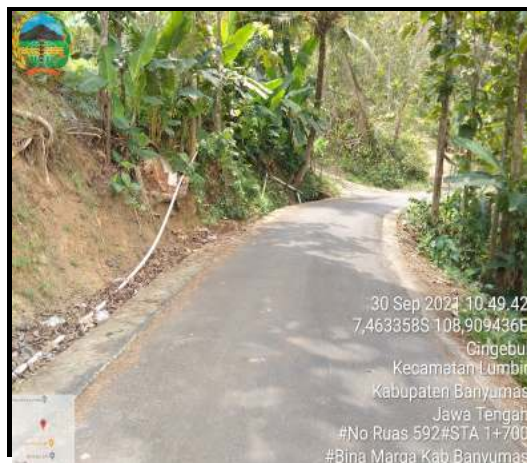
LOKASI : STA 1+700

KONDISI PERKERASAN : Baik  
LEBAR PERKERASAN : 3,4 M  
CATATAN : Hotmix

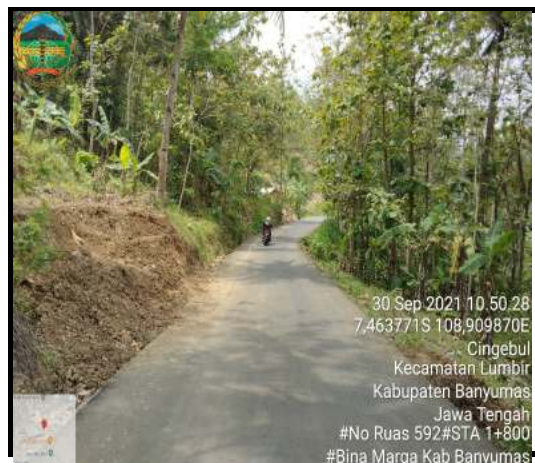
LOKASI : STA 1+800

KONDISI PERKERASAN : Baik  
LEBAR PERKERASAN : 4 M  
CATATAN : Hotmix

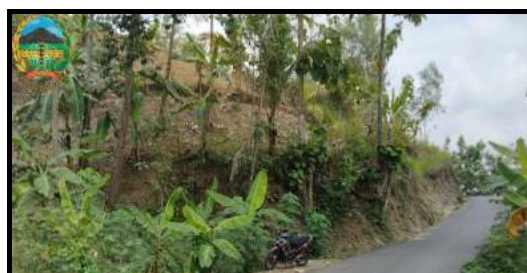
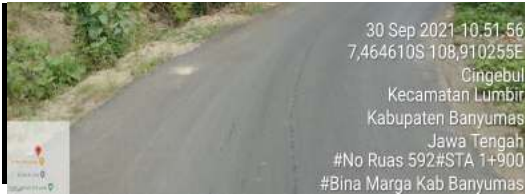
LOKASI : **STA 1+900**

KONDISI PERKERASAN : Baik  
 LEBAR PERKERASAN : 4 M  
 CATATAN : Hotmix

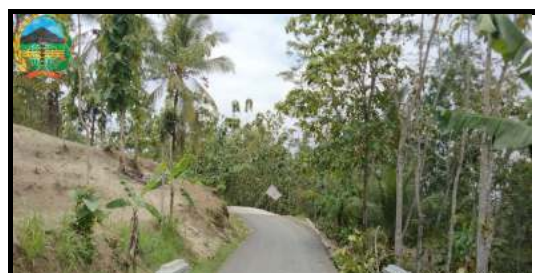
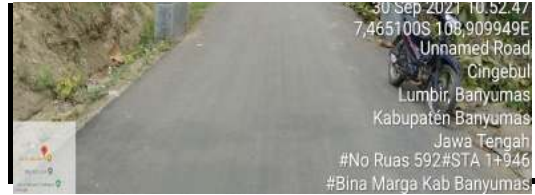
LOKASI : **STA 1+946**

KONDISI PERKERASAN : Baik  
 LEBAR PERKERASAN : 4 M  
 CATATAN : Hotmix
