## FOTO SURVEY KONDISI JALAN TAHUN 2022

RUAS JALAN : Cikawung - Cibangkong

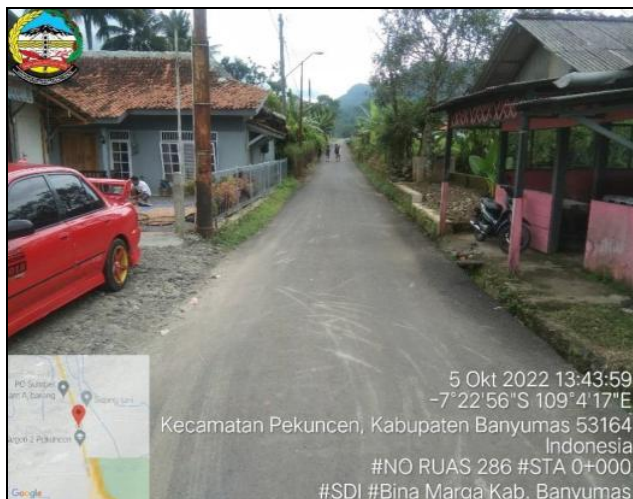
LOKASI :           **STA           0+000**

KONDISI PERKERASAN :       BAIK  
LEBAR PERKERASAN :       3.4           M  
CATATAN :           ASPAL

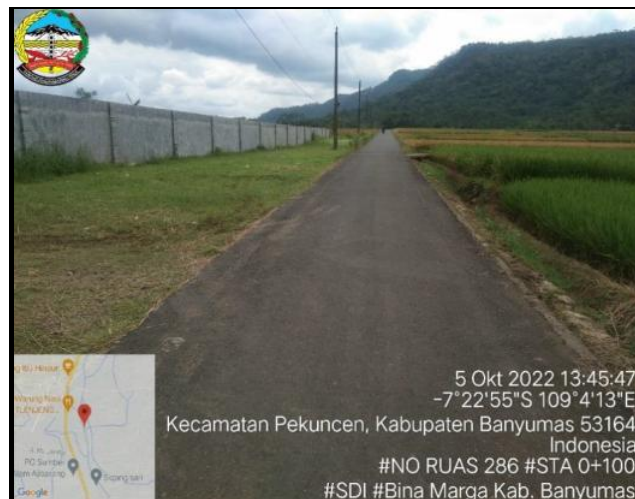
LOKASI :           **STA           0+100**

KONDISI PERKERASAN :       SEDANG  
LEBAR PERKERASAN :       3.4           M  
CATATAN :           ASPAL

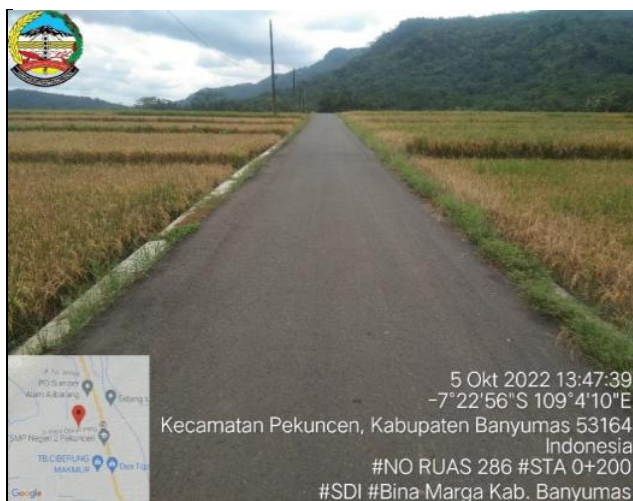
LOKASI :           **STA           0+200**

KONDISI PERKERASAN :       BAIK  
LEBAR PERKERASAN :       3.4           M  
CATATAN :           ASPAL

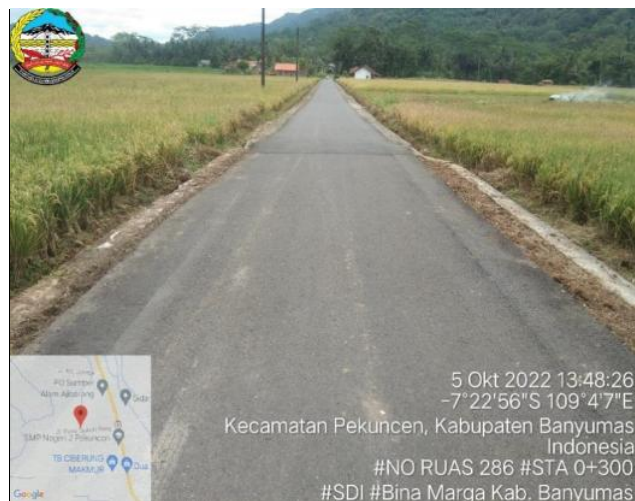
LOKASI :           **STA           0+300**

KONDISI PERKERASAN :       BAIK  
LEBAR PERKERASAN :       3.4           M  
CATATAN :           ASPAL

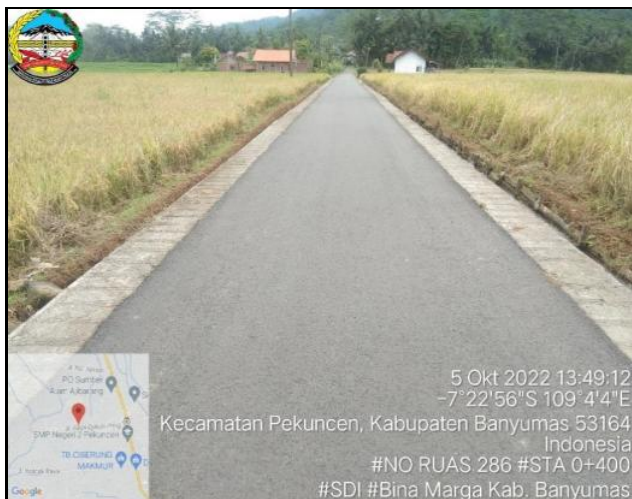
LOKASI :           **STA           0+400**

KONDISI PERKERASAN :       BAIK  
LEBAR PERKERASAN :       3.4           M  
CATATAN :           ASPAL

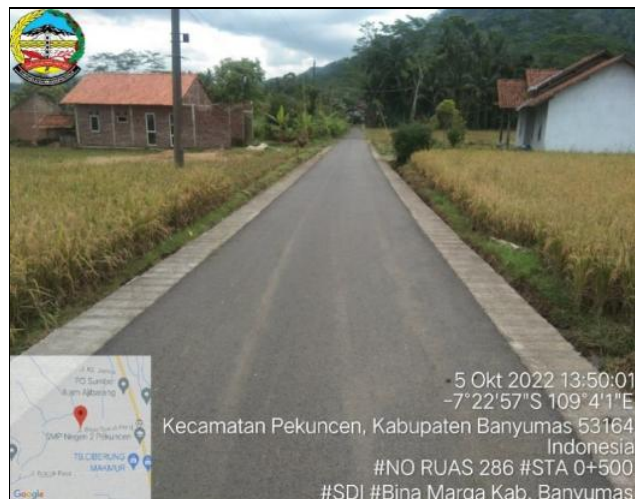
LOKASI :           **STA           0+500**

KONDISI PERKERASAN :       BAIK  
LEBAR PERKERASAN :       3.4           M  
CATATAN :           ASPAL

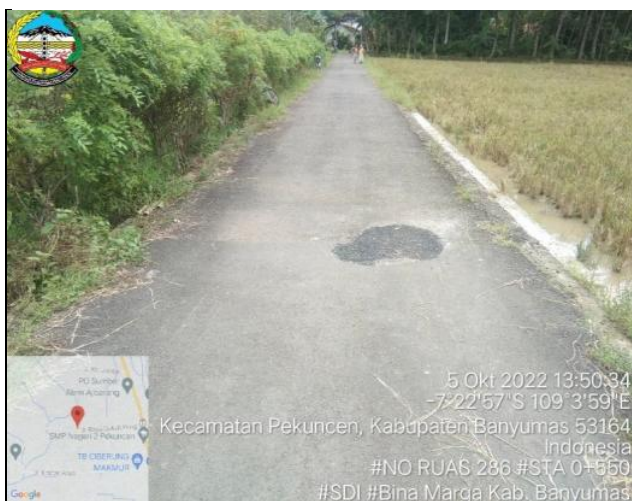
LOKASI :           **STA           0+550**

KONDISI PERKERASAN :       SEDANG  
LEBAR PERKERASAN :       3.4           M  
CATATAN :           ASPAL

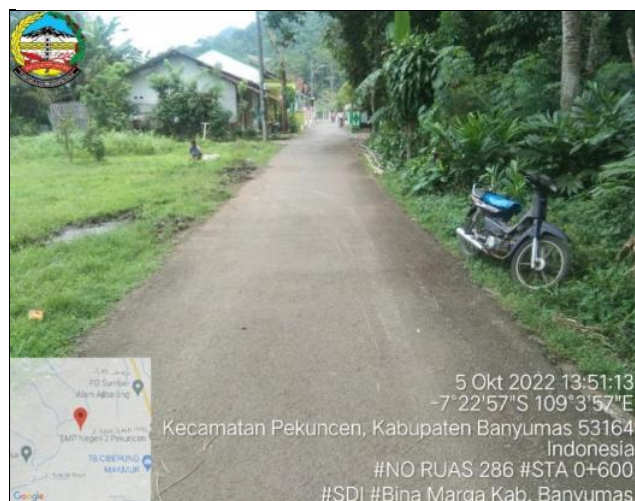
LOKASI :           **STA           0+600**

KONDISI PERKERASAN :       SEDANG  
LEBAR PERKERASAN :       3.4           M  
CATATAN :           ASPAL

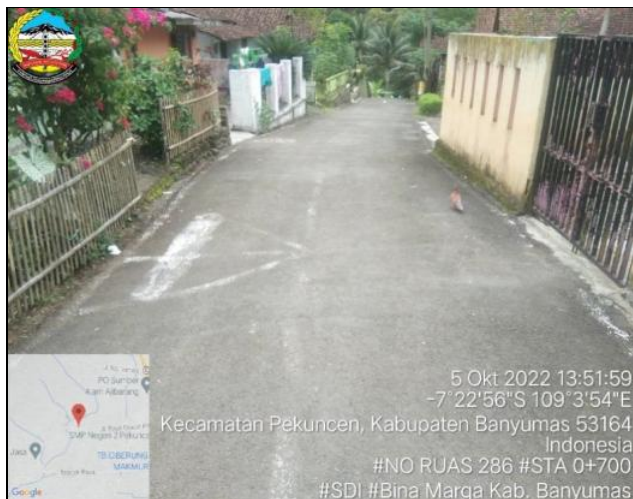
LOKASI :           **STA           0+700**

KONDISI PERKERASAN :       BAIK  
LEBAR PERKERASAN :       3.4           M  
CATATAN :           ASPAL

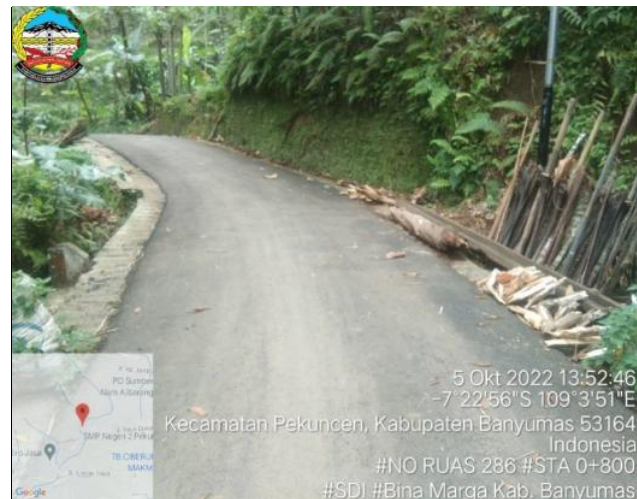
LOKASI :           **STA           0+800**

KONDISI PERKERASAN :       BAIK  
LEBAR PERKERASAN :       3           M  
CATATAN :           ASPAL

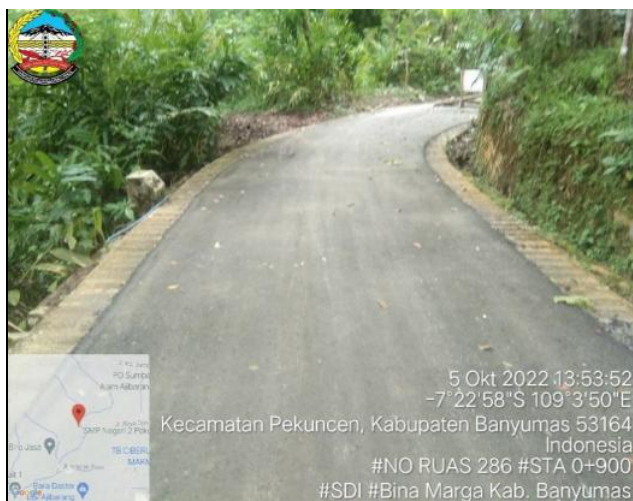
LOKASI :           **STA           0+900**

KONDISI PERKERASAN :       BAIK  
LEBAR PERKERASAN :       3           M  
CATATAN :           ASPAL

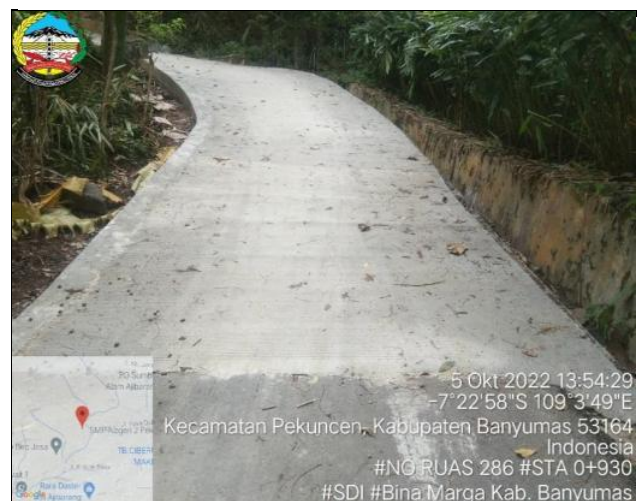
LOKASI :           **STA           0+930**

KONDISI PERKERASAN :       BAIK  
LEBAR PERKERASAN :       3.8           M  
CATATAN :           BETON

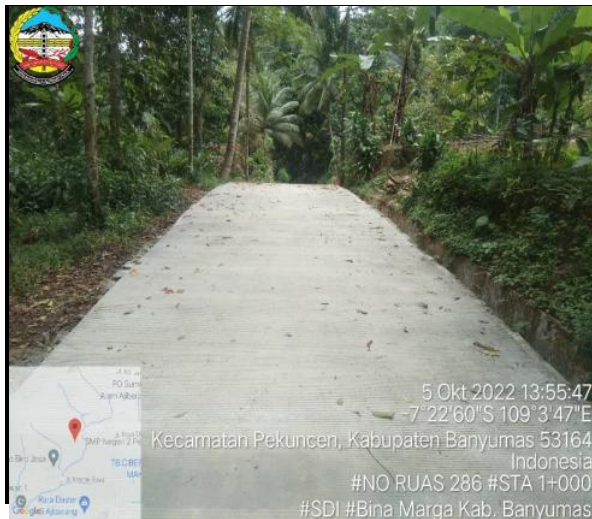
LOKASI : **STA 1+000**

KONDISI PERKERASAN : BAIK  
LEBAR PERKERASAN : 3.5 M  
CATATAN : BETON

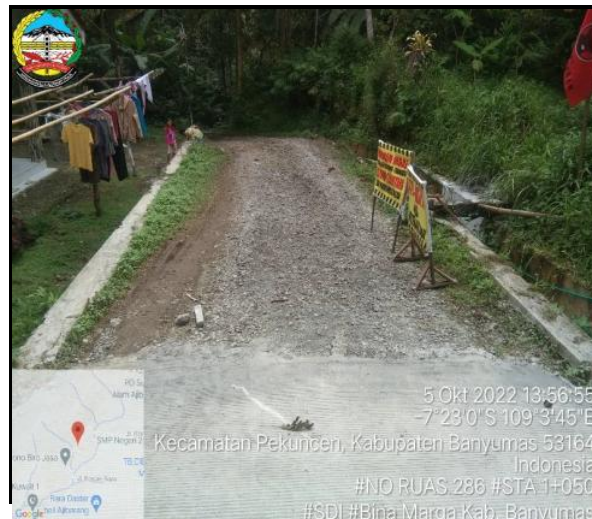
LOKASI : **STA 1+050**

KONDISI PERKERASAN : RUSAK BERAT  
LEBAR PERKERASAN : 2.5 M  
CATATAN : ASPAL

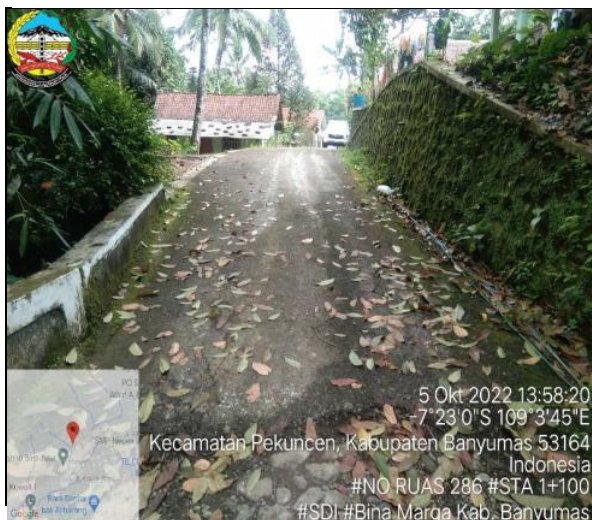
LOKASI : **STA 1+100**

KONDISI PERKERASAN : SEDANG  
LEBAR PERKERASAN : 3.6 M  
CATATAN : ASPAL

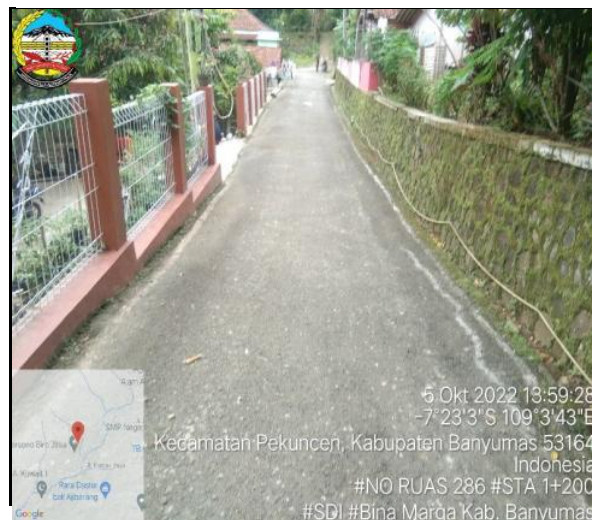
LOKASI : **STA 1+200**

KONDISI PERKERASAN : SEDANG  
LEBAR PERKERASAN : 3.6 M  
CATATAN : ASPAL

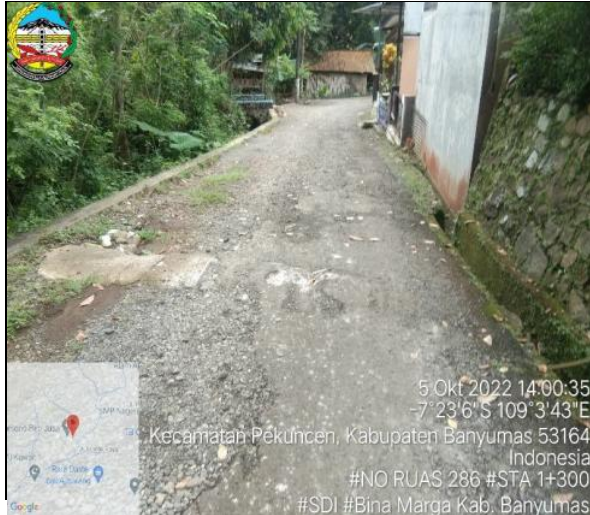
LOKASI : **STA 1+300**

KONDISI PERKERASAN : **RUSAK BERAT**

LEBAR PERKERASAN : **3 M**

CATATAN : **ASPAL**

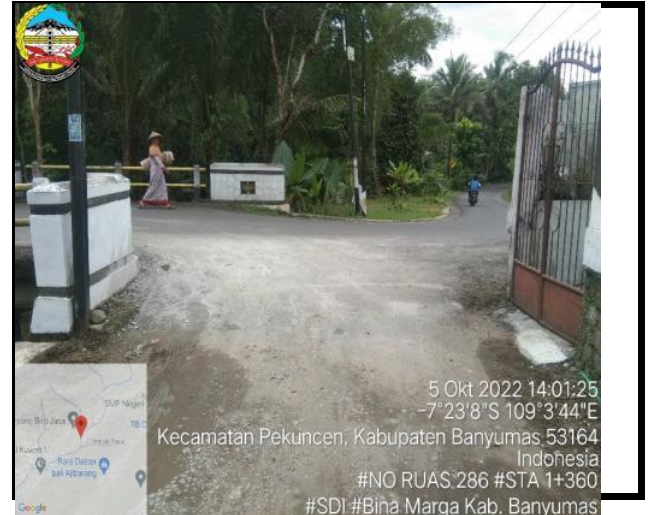
LOKASI : **STA 1+360**

KONDISI PERKERASAN : **RUSAK BERAT**

LEBAR PERKERASAN : **3 M**

CATATAN : **ASPAL**
